# Manhole Inspection Summary

Manhole # S53G\_\_001MH

Record Plat: **53G** Node: **001** Status: **Found**

**Location** Address: **3301 S Clinton St**

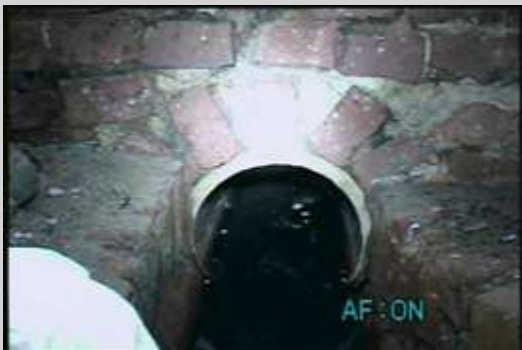
12 O'Clock Outflow

8 in. Circular Gravity Sewer  
Pipe Out @ 12 O'Clock

Pipe Material: Clay ☐ Pipe Lined

Invert Depth: 5.88 (ft.) Flow Characteristics: Slow

Infiltration: None Pipe Seal Cond: Unknown

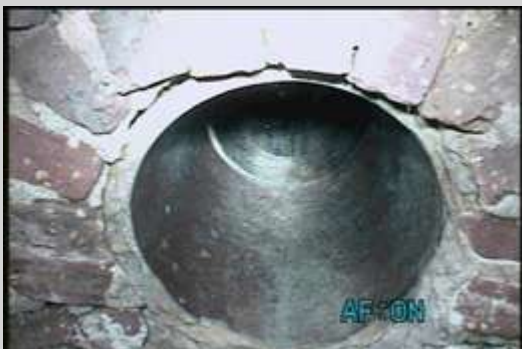
3 O'Clock Inflow

8 in. Circular Gravity Sewer  
Pipe In @ 3 O'Clock

Drop In @ 3 O'Clock

Pipe Material: Clay ☐ Pipe Lined

Infiltration: None Pipe Seal Cond: Unknown

Drop Condition: Open
